## INFORMATION SHEET

The following series of photographs show the construction of what is now a busy road in Phnom Penh, Cambodia. (Phnom Penh is the capital and largest city and is the political, economic, and cultural center of Cambodia).

It is now nearly 15 years since the dirt road was converted to a heavy duty highway and which was sealed with a two coat bitumen emulsion/chip layer.

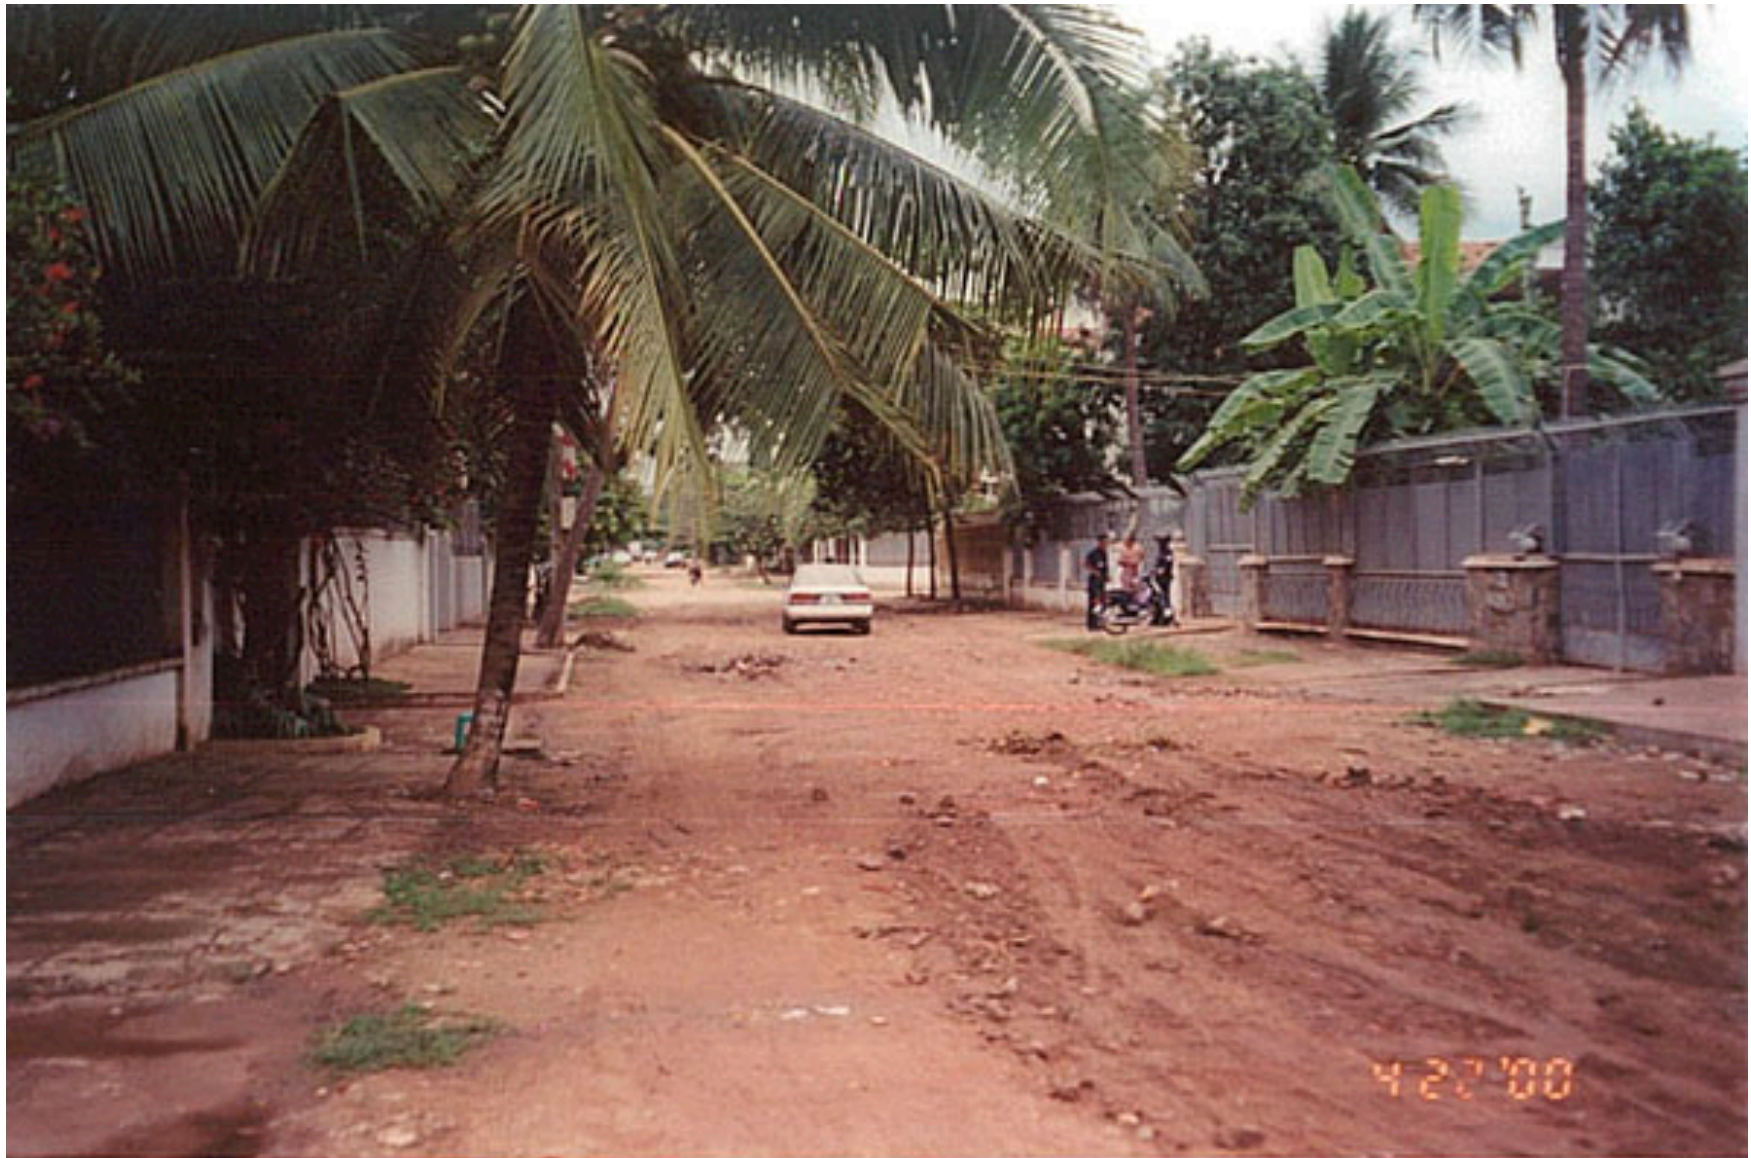
The Initial state of the street in Cambodia

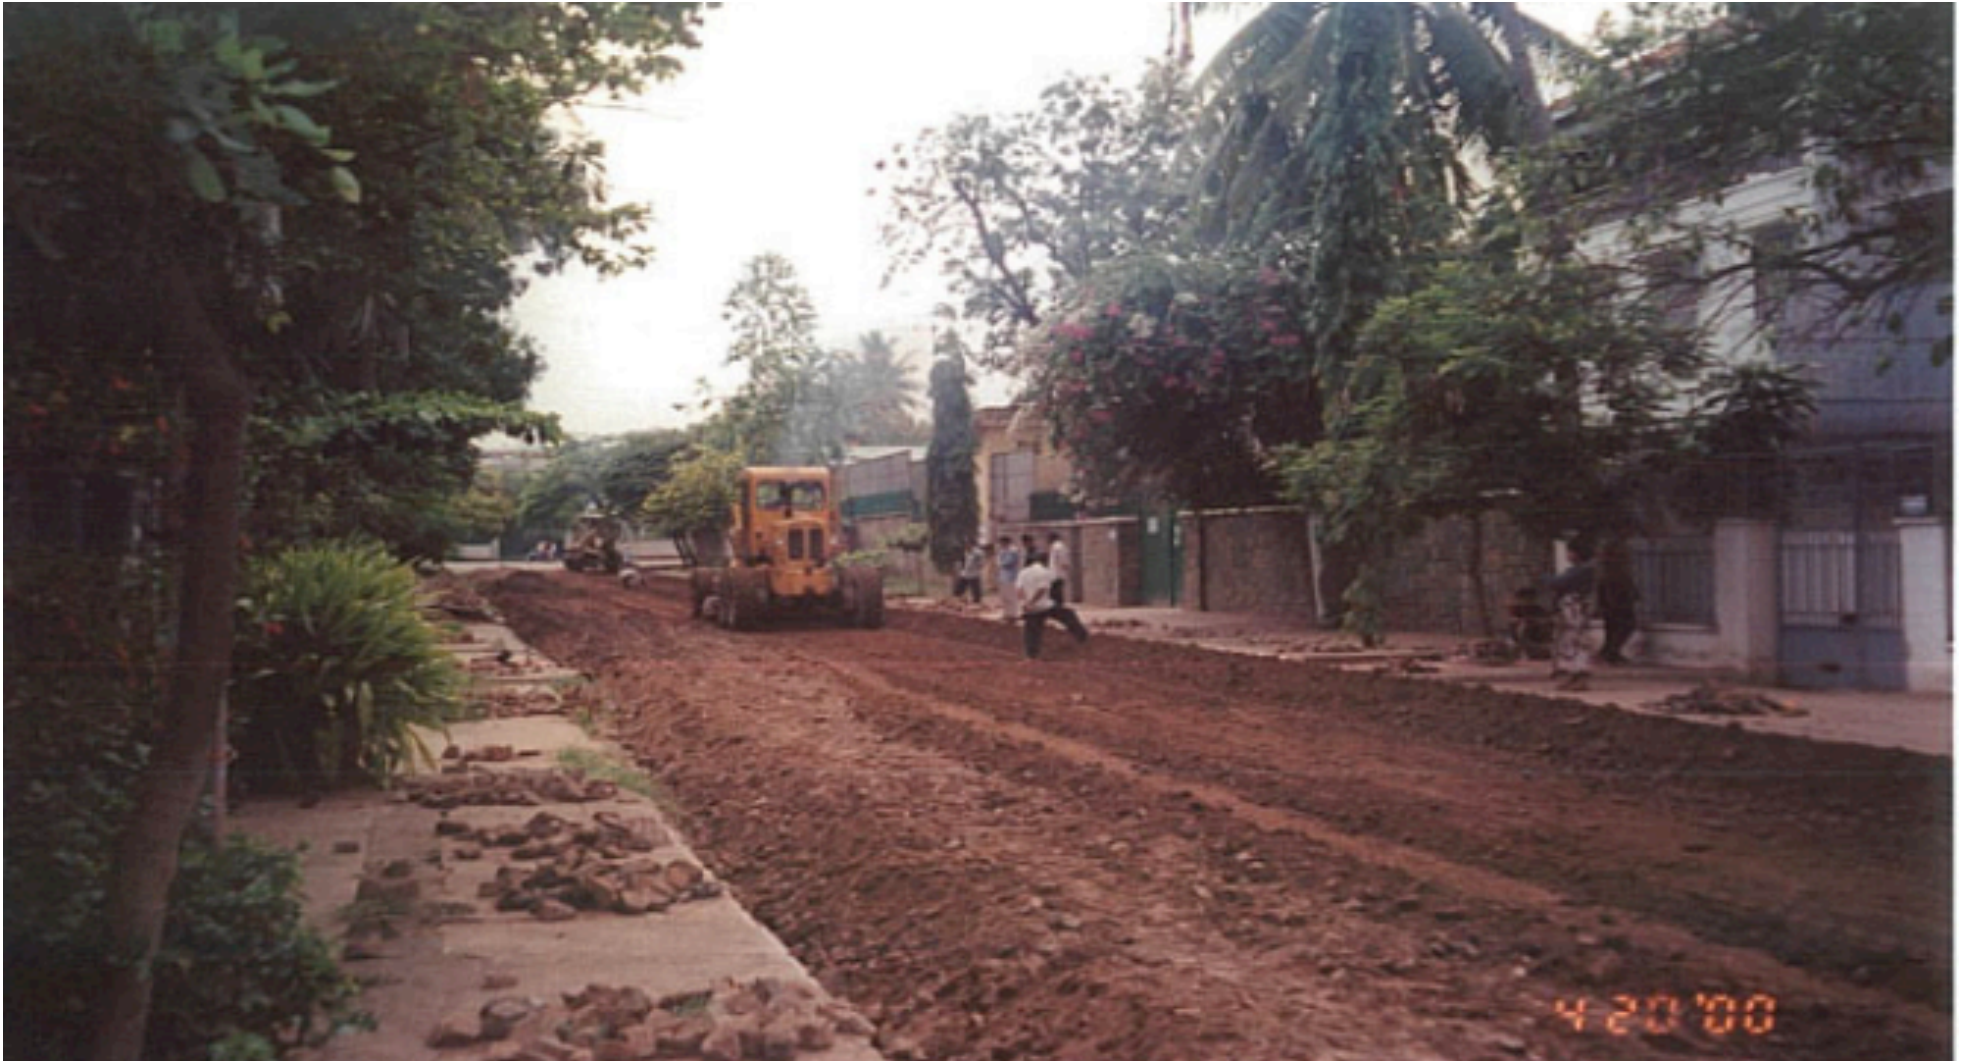
Using a grader to work up the soil. Big stones removed

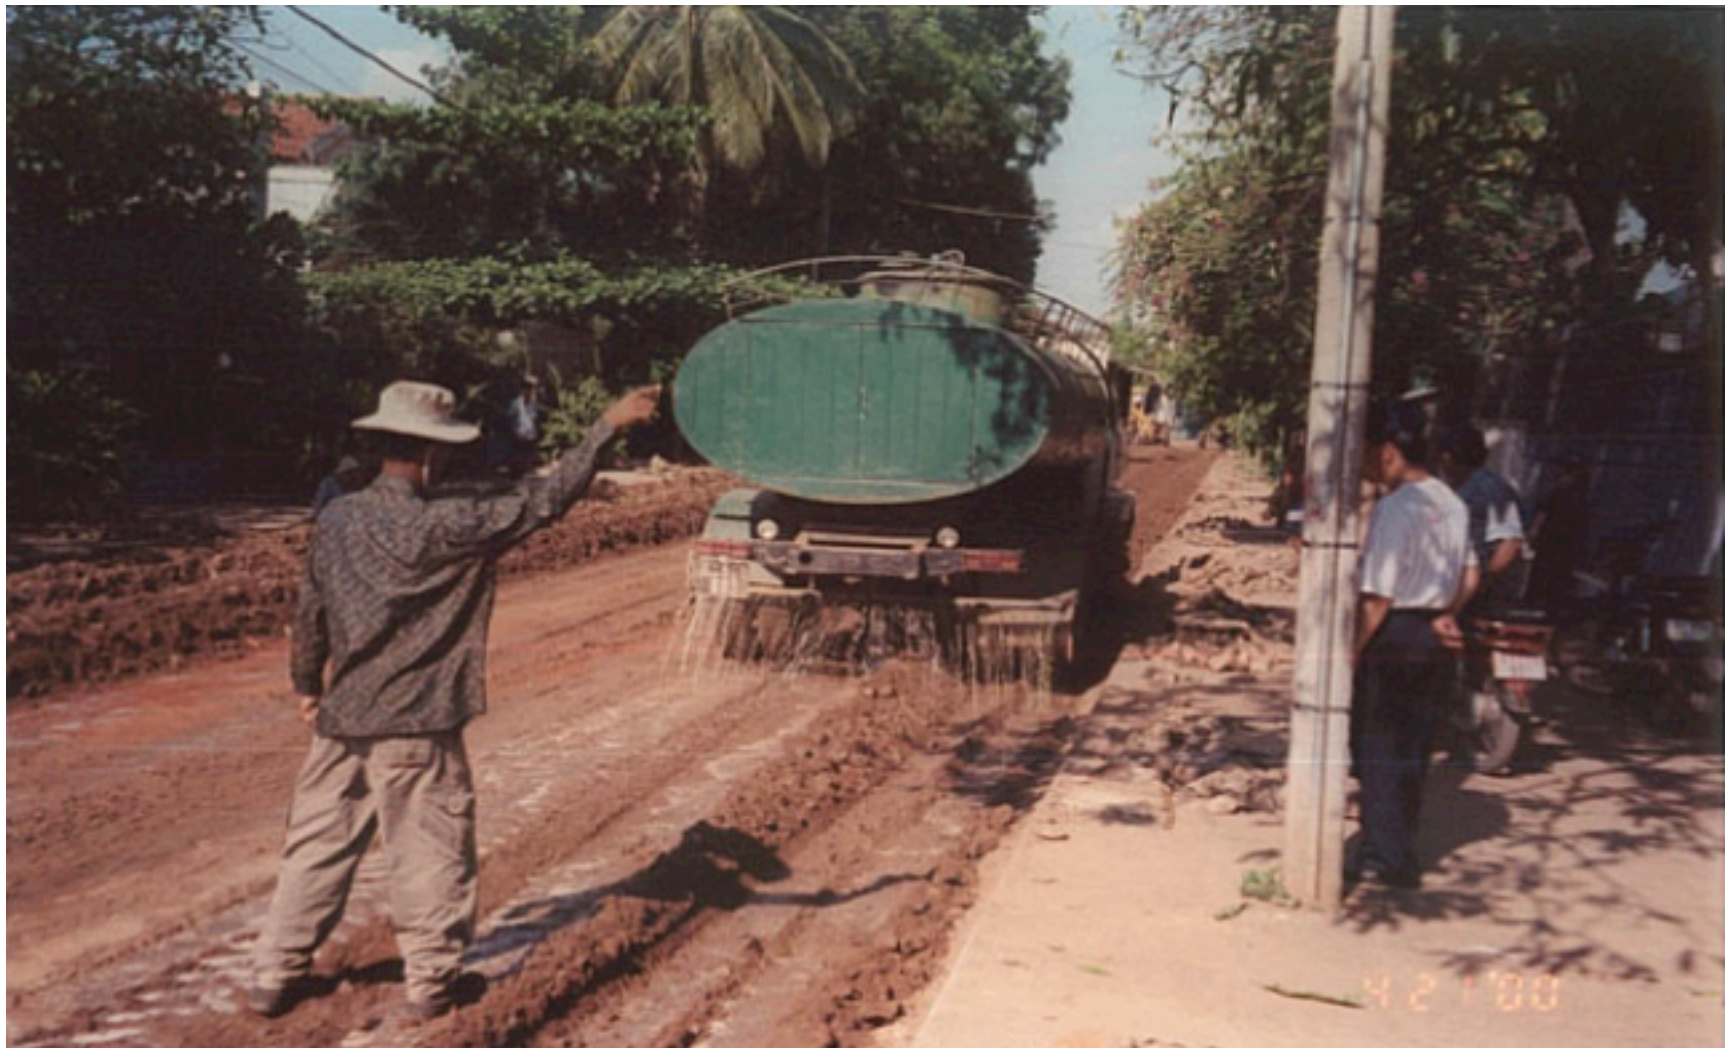
Application of the very dilute Firmament solution.

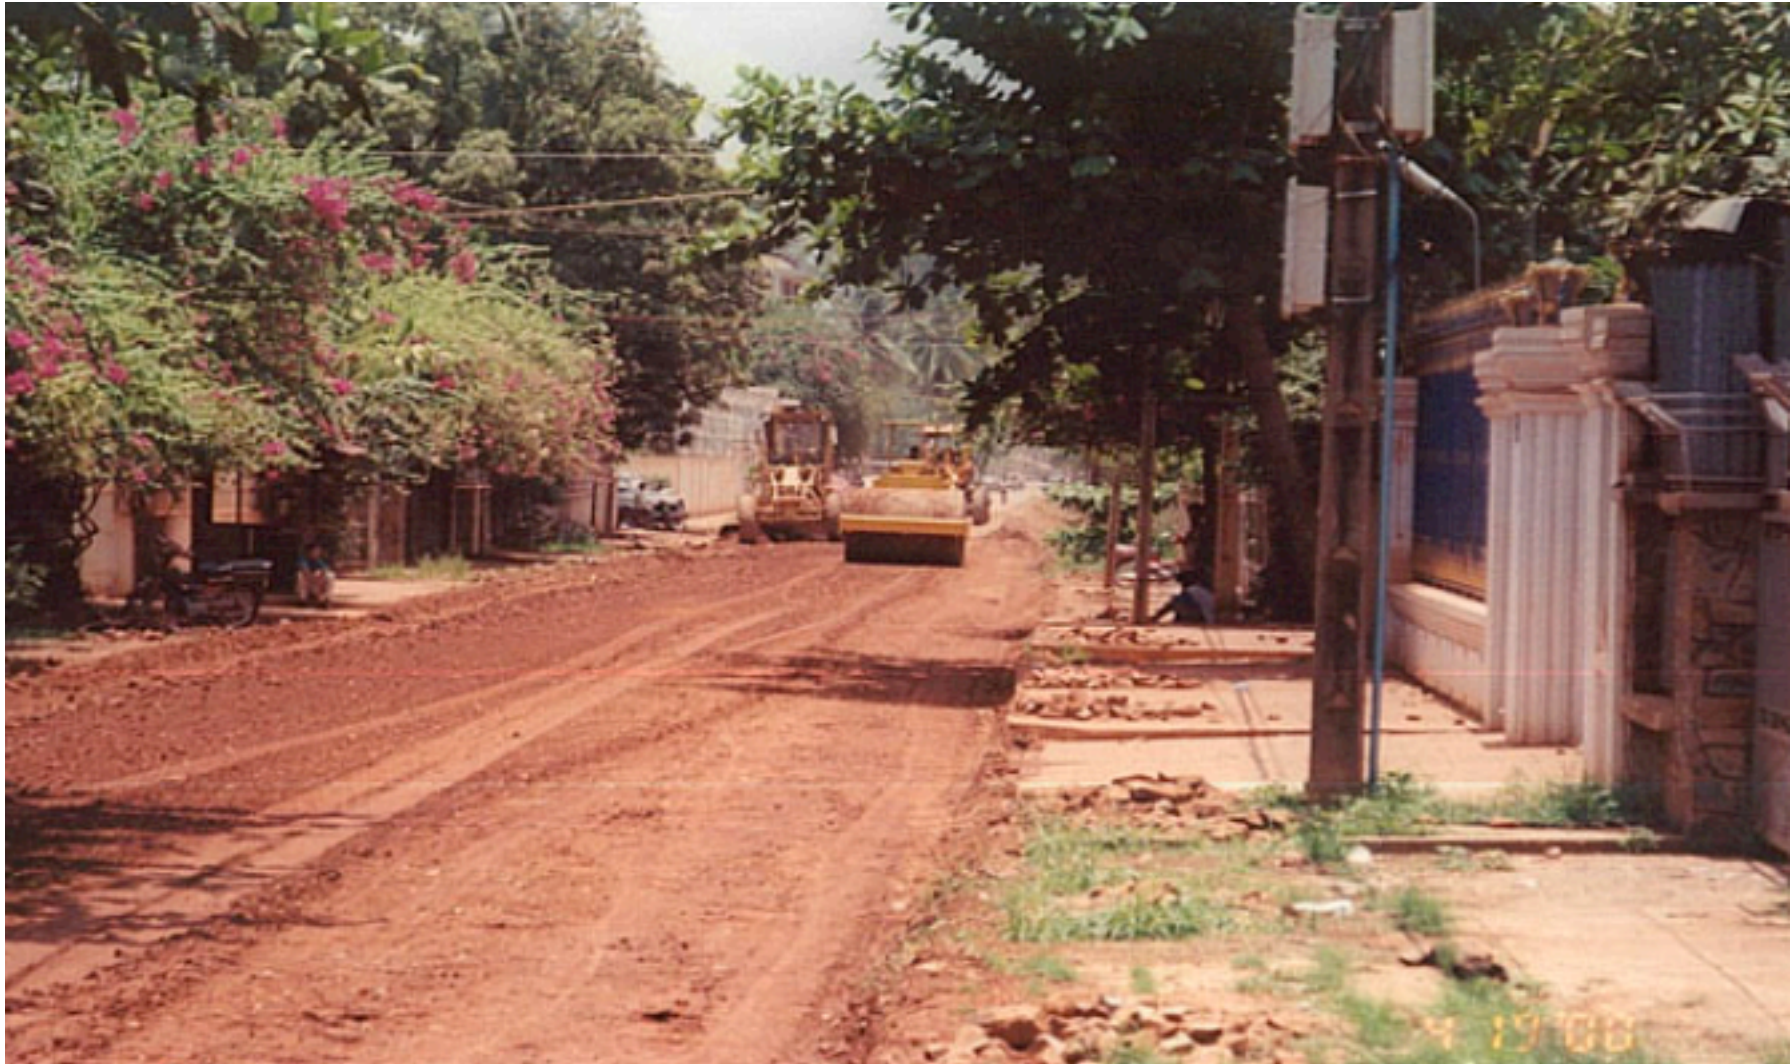
Consolidation and shaping with 10 tonne roller and grader.

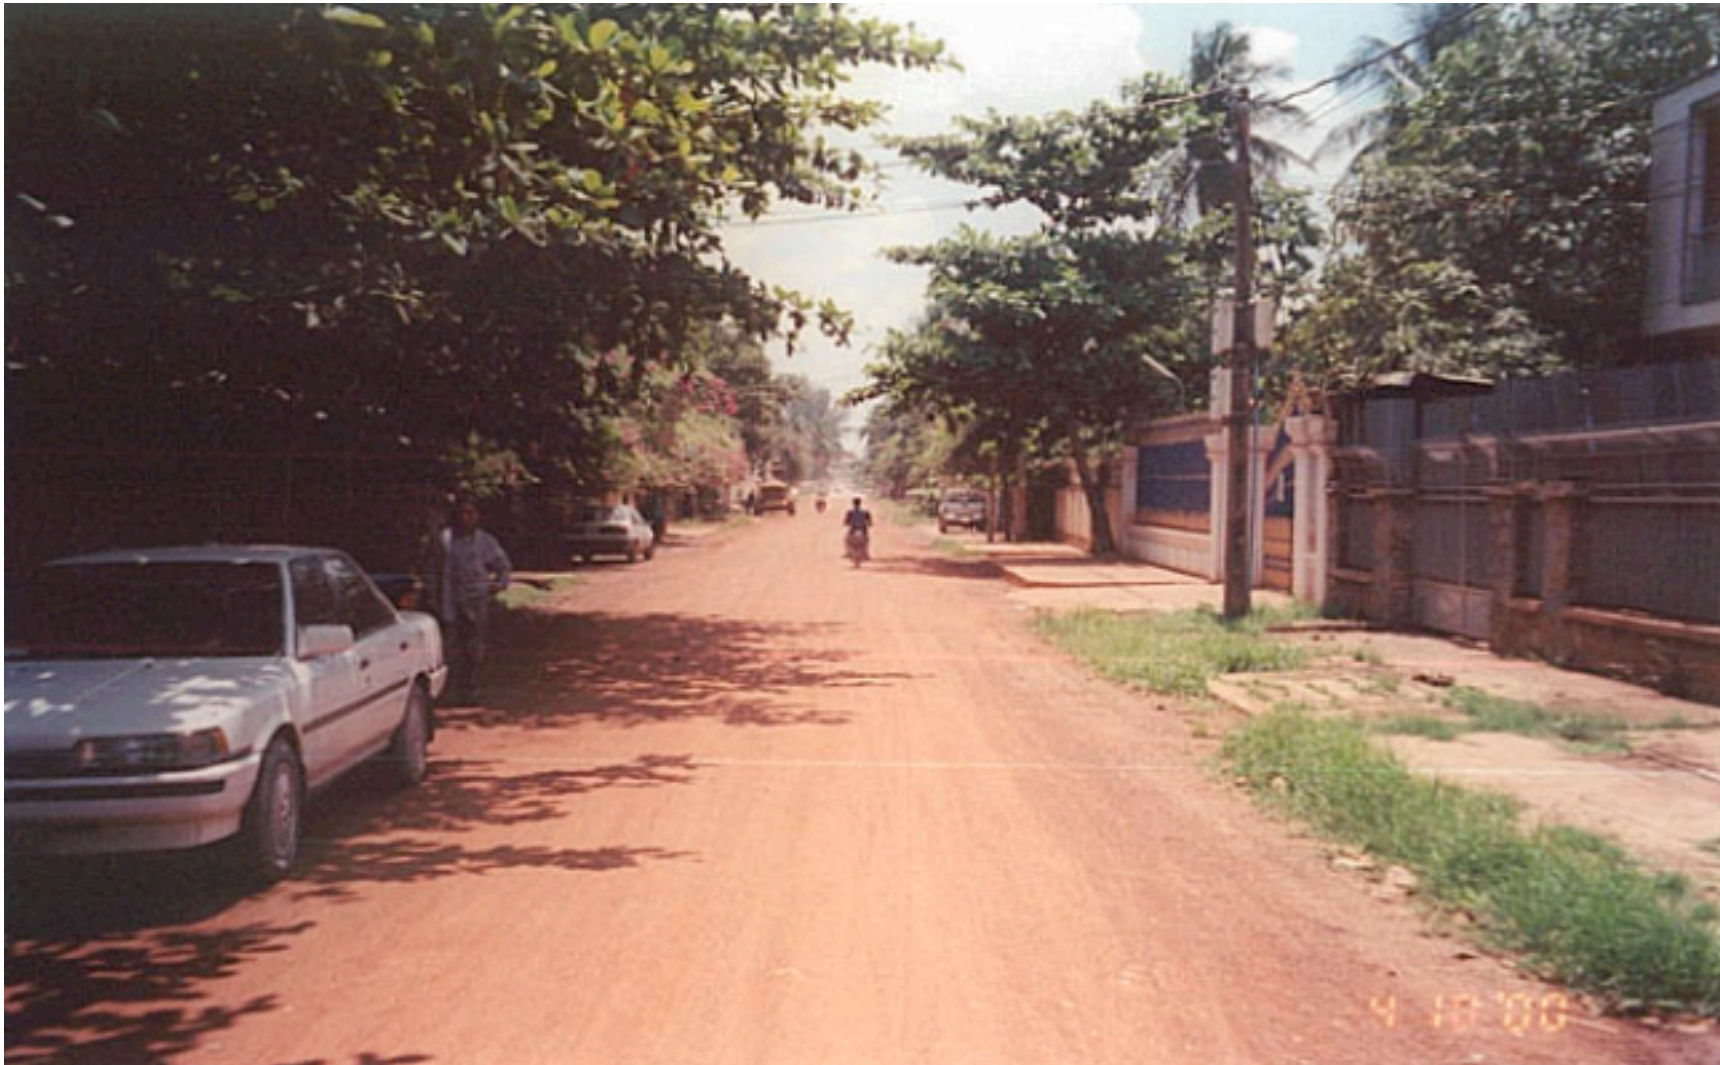
Finished and consolidated Road

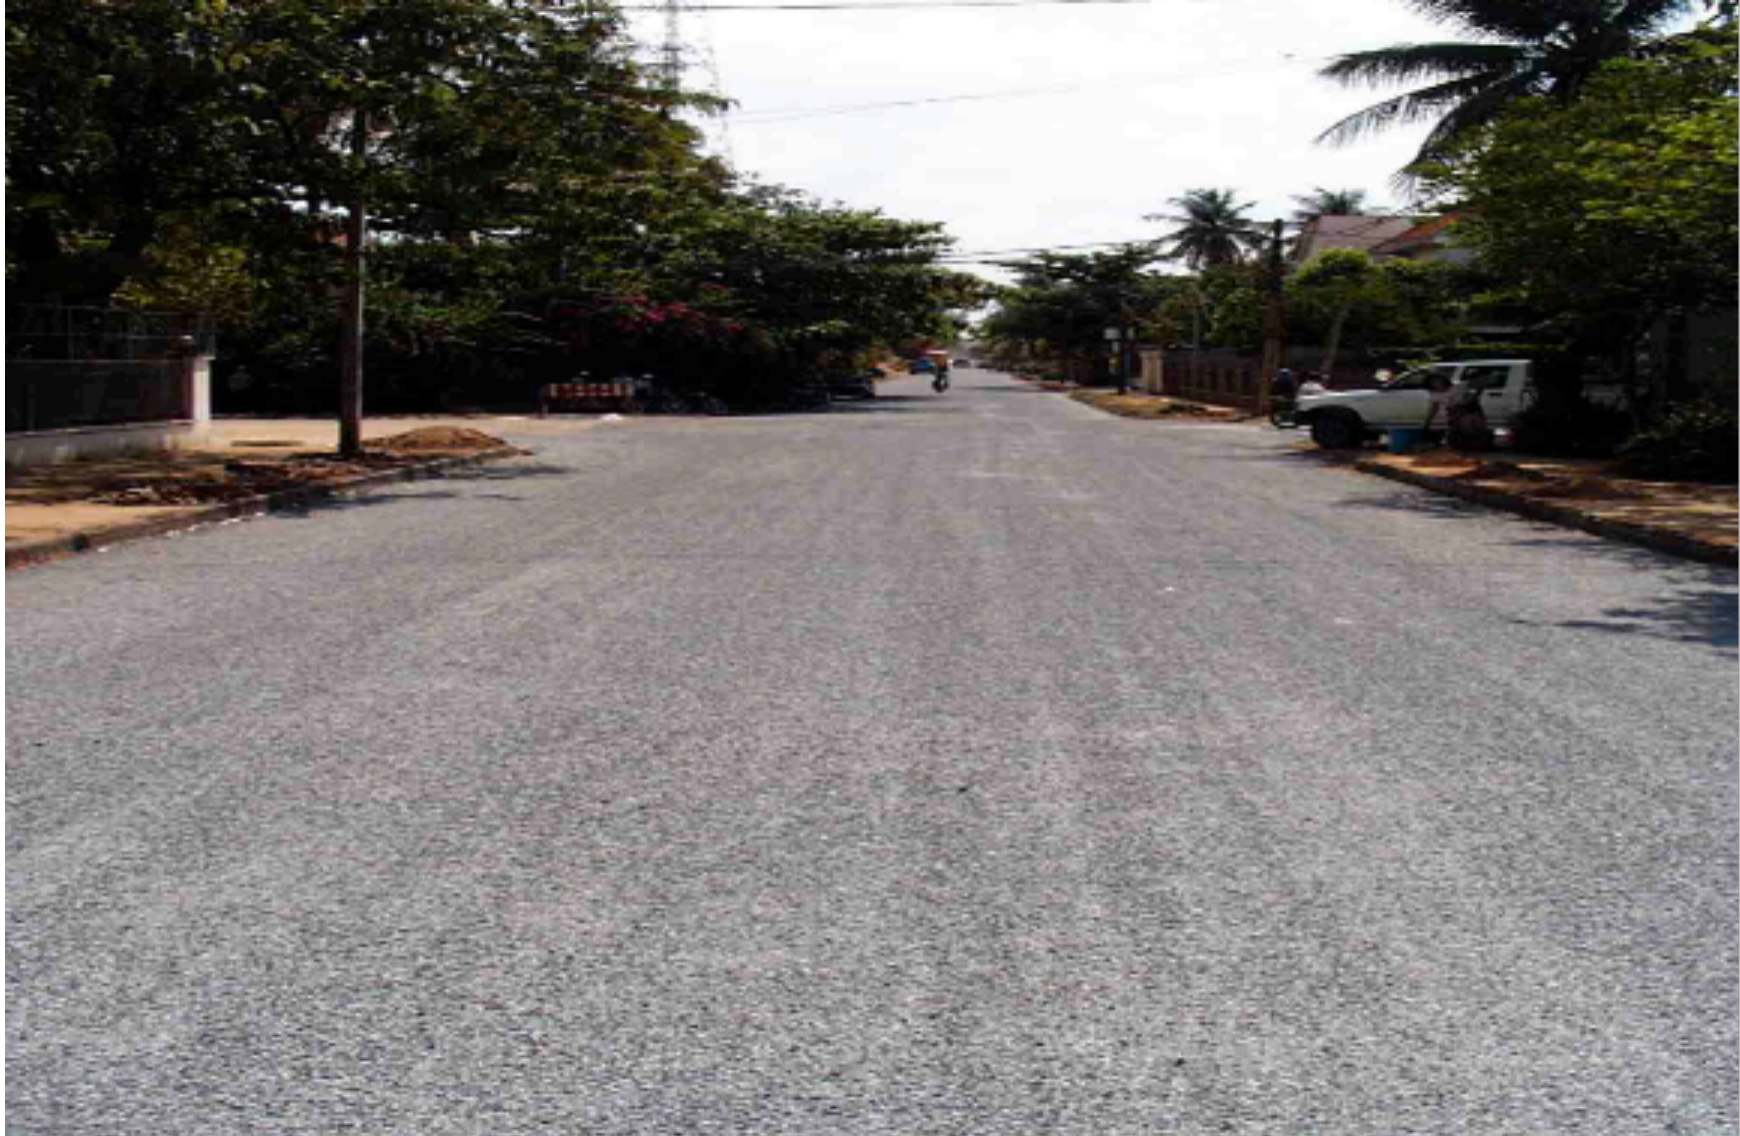
Chipseal applied on bitumen cut with diesel

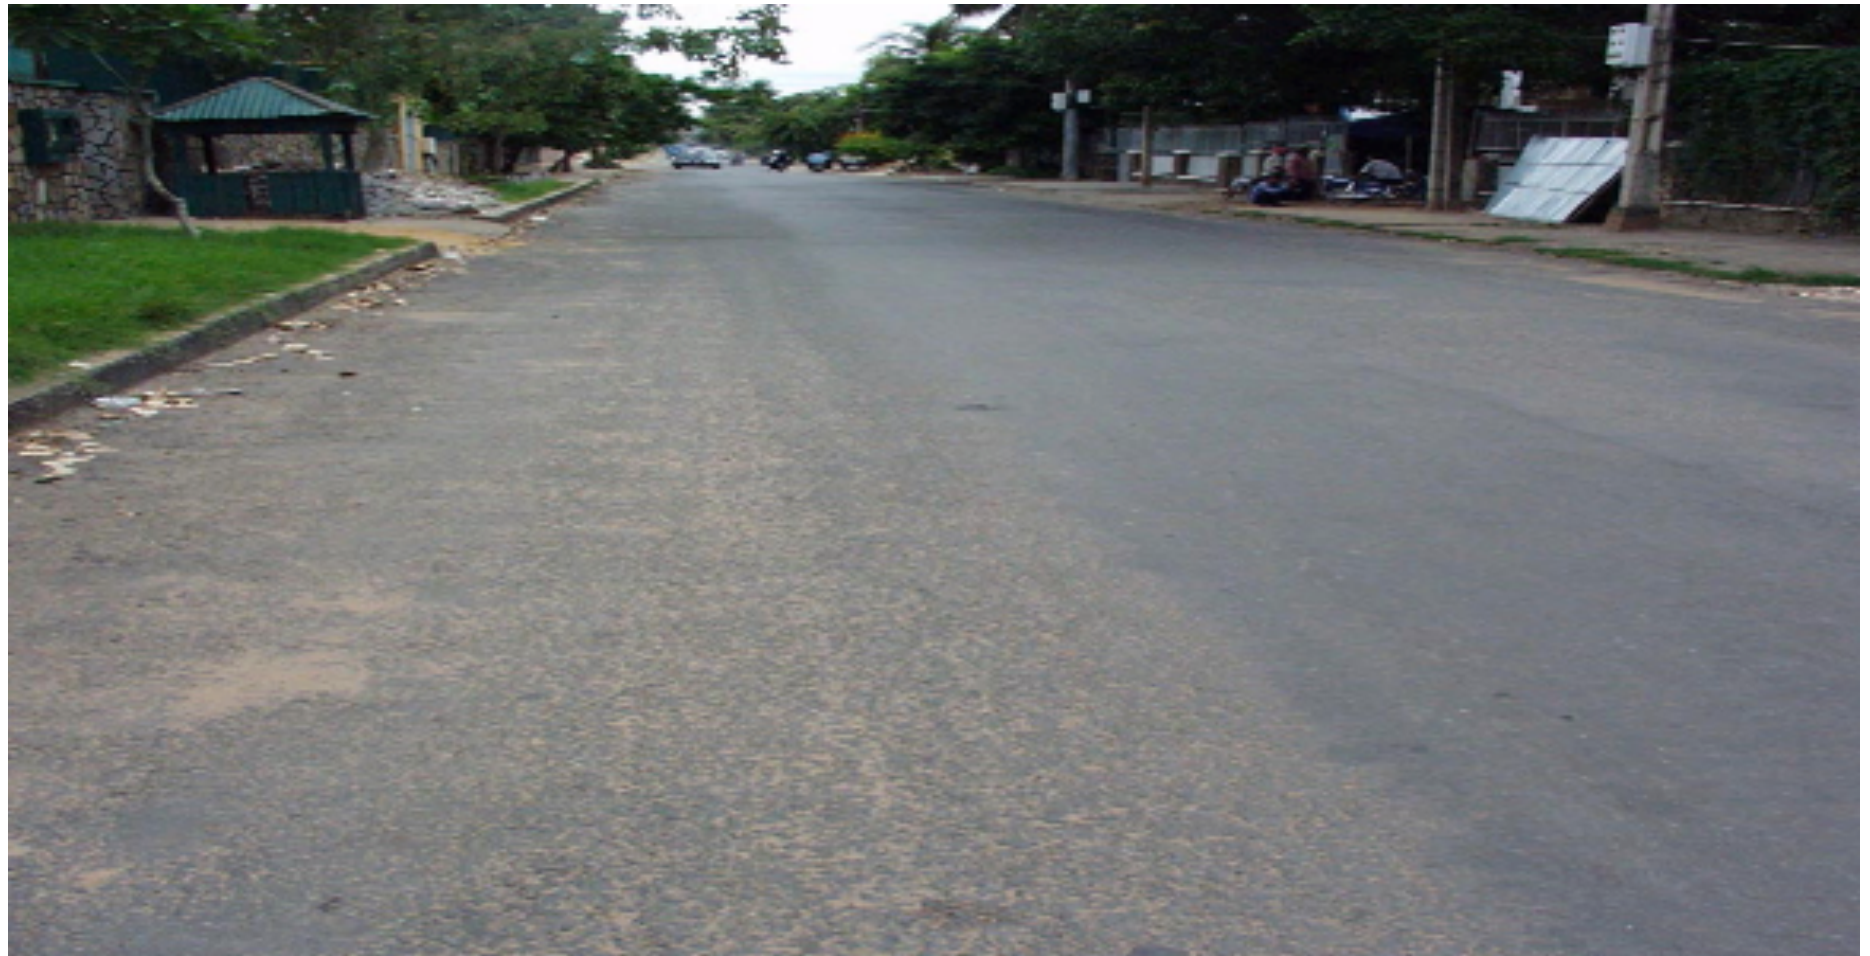
The road in Phnom Penh On the side of the road so you can see what happens when the chipseal surface is not so heavily trafficked. You still can see the stone. The center of the road gets **very heavy container traffic all day** so it has become more compressed and looks more like a traditional hot mix asphalt road. This road was 8 years old when this photos was taken. No repairs have ever been done on this road and we don't expect any for many years. The last report about the state of the road was in S2012 and the road looked much the same as the final 2007 photo except that less rock was visible. This happens with chipseal as the emulsion softens slightly in the hot weather and traffic pushes down the rock making the whole road eventually look like hot mix asphalt. ( It can be assumed that there will be little change as at 2015 ).
